Subject: Monitoring Well Summary Report for  
Lusher Street Groundwater Contamination Site, Elkhart, Indiana  
Contract EP-S5-06-02, Work Assignment No. 136-RICO-05AB

Monitoring Well Inventory Table  
Lusher Street Groundwater Contamination Site  
January 2017

Lusher Street Groundwater Contamination Site

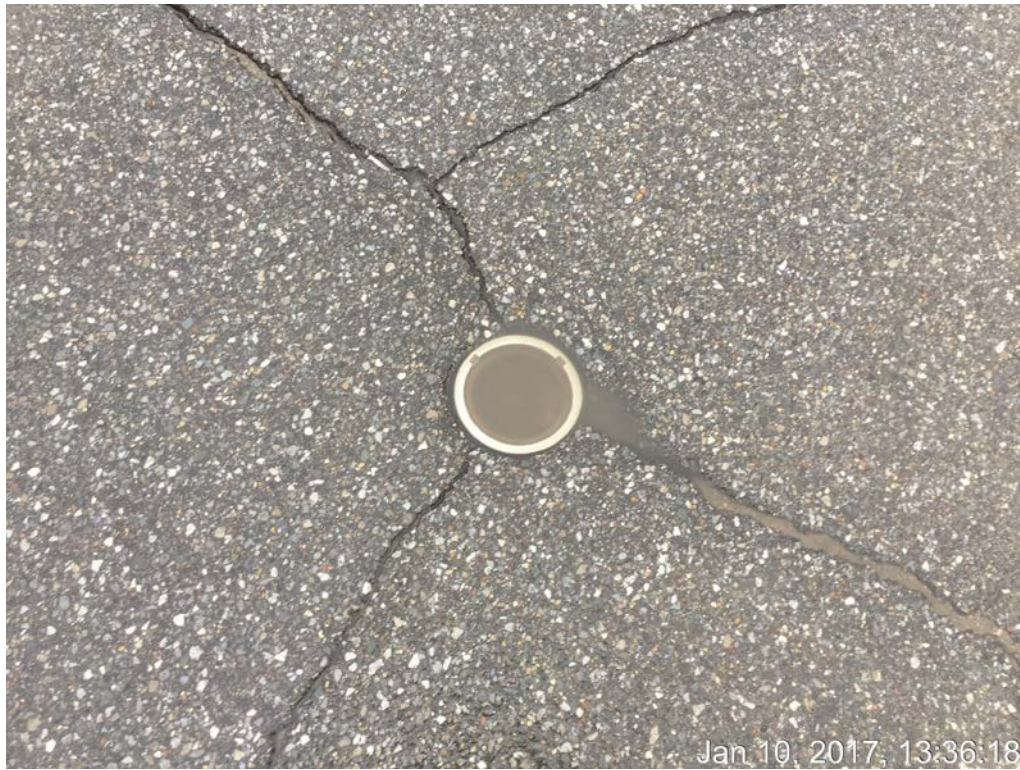
Photograph #1 – MW-001 on Hively Blvd.

Well IDs	Location	No. of Wells <sup>1</sup>	Visual Well Condition/Notes	Corrective Recommendations
MW-001	Hively Avenue and 17th Street	1	Well cap and J-plug were missing. Water was observed at the surface.	Pump out monitoring well. If well integrity is good, provide new J-plug and well cover.
MW-003	Fieldhouse Avenue between Nappanee and 20th Streets	4	Well caps require new bolts on at least one cap, otherwise good.	Replace well cap bolts. <sup>2</sup>
MW-005	On private property	1	NA	
MW-006	On private property	3	NA	
MW-008	Waurika Street between Illinois and Franklin Streets	2	One well is good and the other is missing the well cap and J-plug with dirt packed into the well.	Replace well cap bolts in good well. <sup>2</sup> Clean out other well, assess well screen integrity. If good, provide new J-plug and well cover. If compromised, abandon well.
MW-009	Franklin Street	2	One well is missing the well cap and J-plug. The second well is paved over with asphalt.	Clean out well, assess well screen integrity. If good, provide new J-plug and well cover, If compromised, abandon well. The same came be done on the well that was paved over, but will require removing the asphalt first.

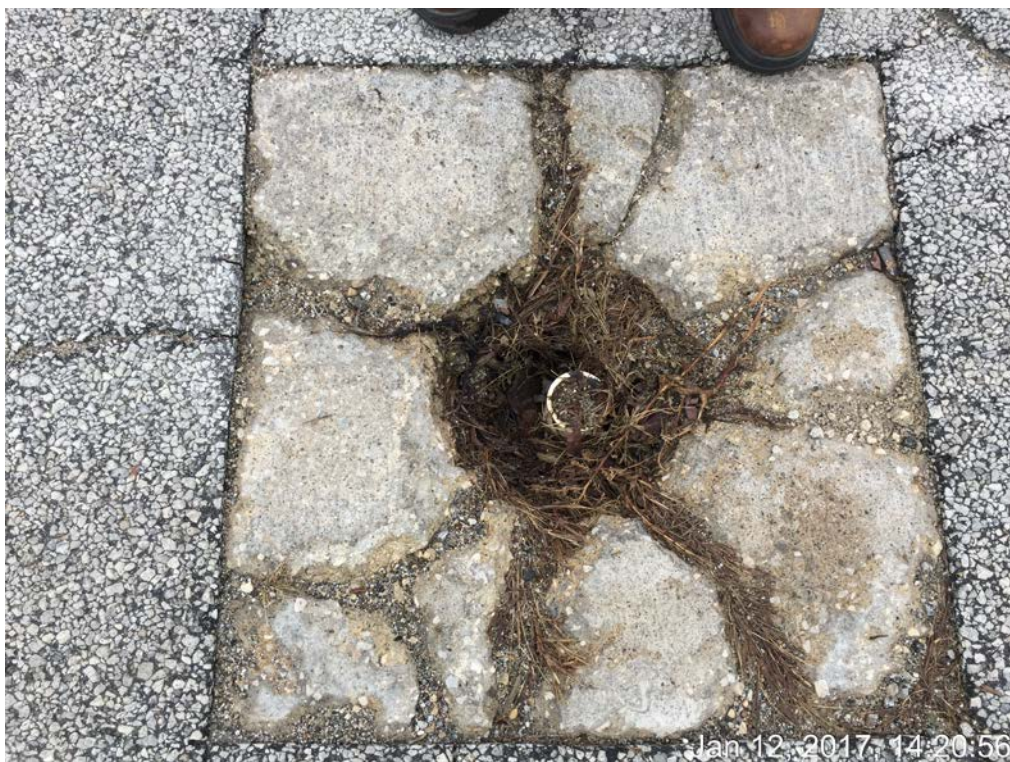
Photograph #2 – MW-008 on Waurika Street. Unknown as to whether it the shallow or deep well.

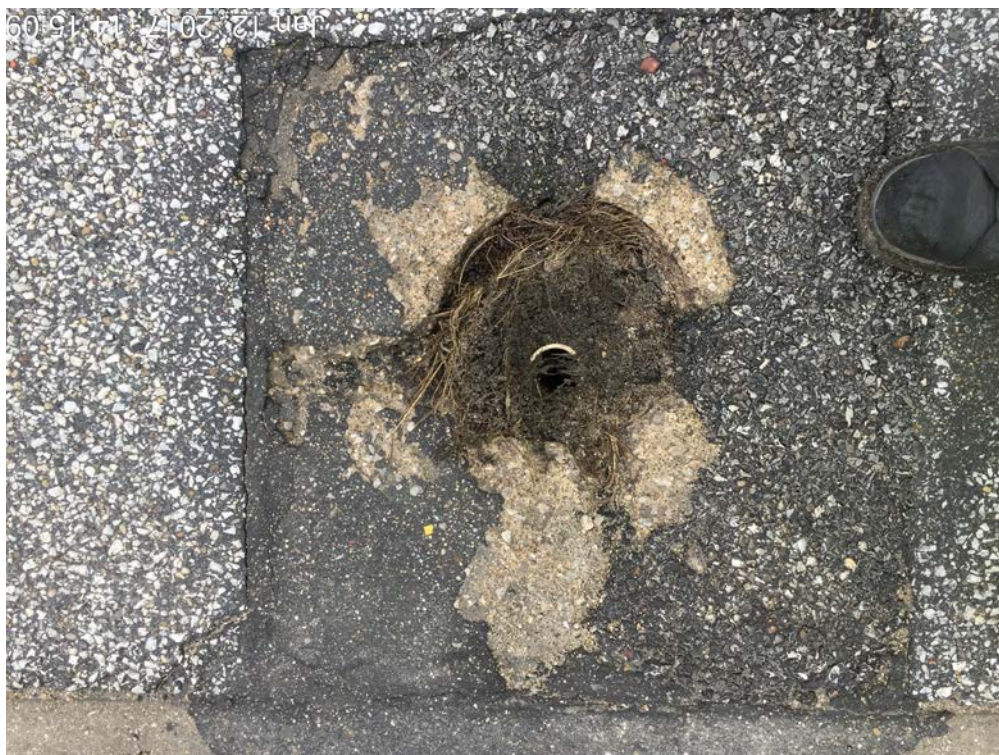
Photograph #3 – MW-009 on Franklin Street; unknown as to whether it is the shallow or intermediate well.

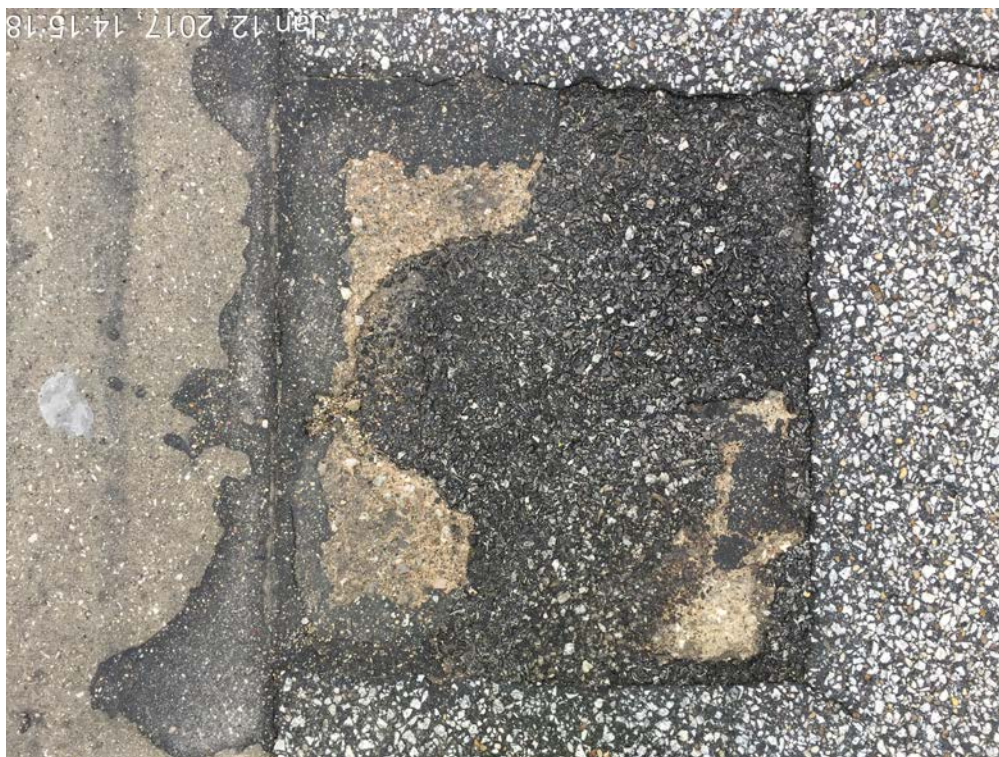
Photograph #4 – Paved over monitoring well at location MW-009 on Franklin Street.

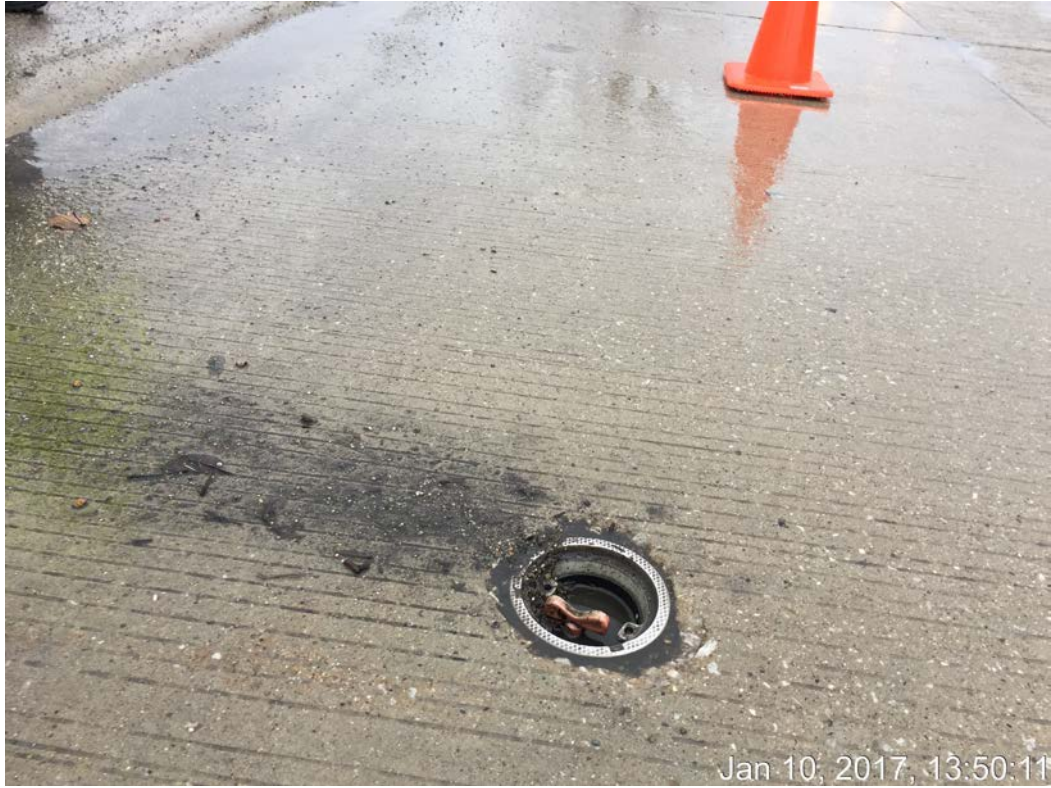
Photograph #5 – MW-111 on Hively Blvd.

MW-111	Hively Avenue and Nappanee Street	1	Well cap is missing, J-plug is good. No obstruction noted during well inventory.	Replace well cap/cover.
